STABILITY ANALYSIS OF RIVER EMBANKMENT AT KATHAUTIA OPENCAST MINE

Prepared for

HINDALCO INDUSTRIES LIMITED

November 2020

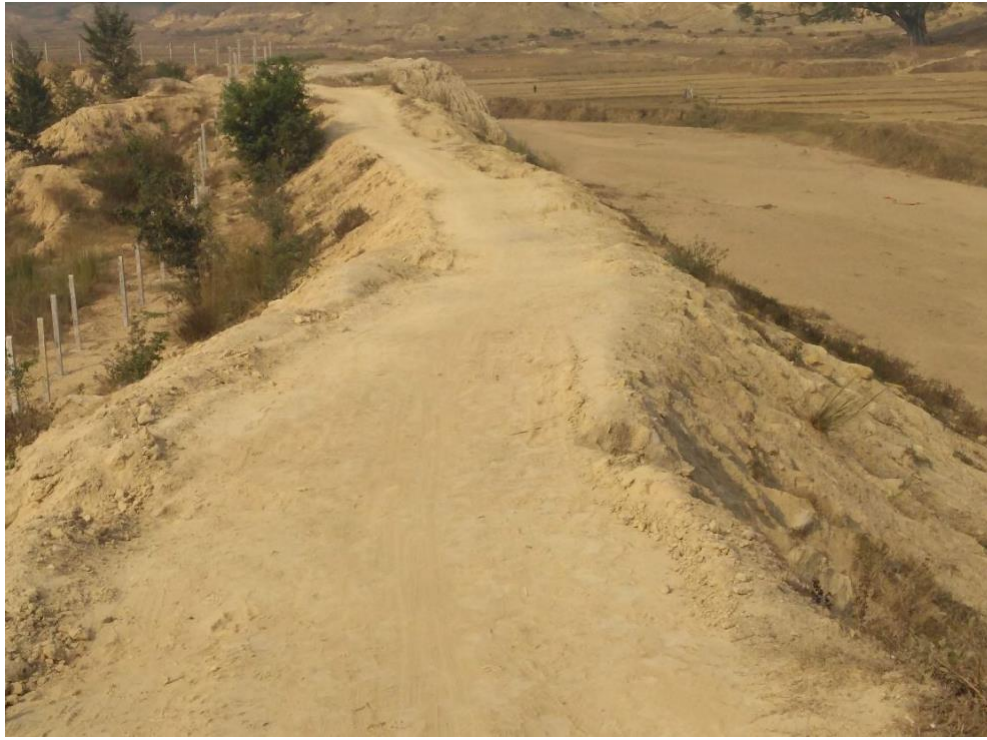
Figure 2: General view of the embankment top from the northern end, visible on the right is the dry river bed

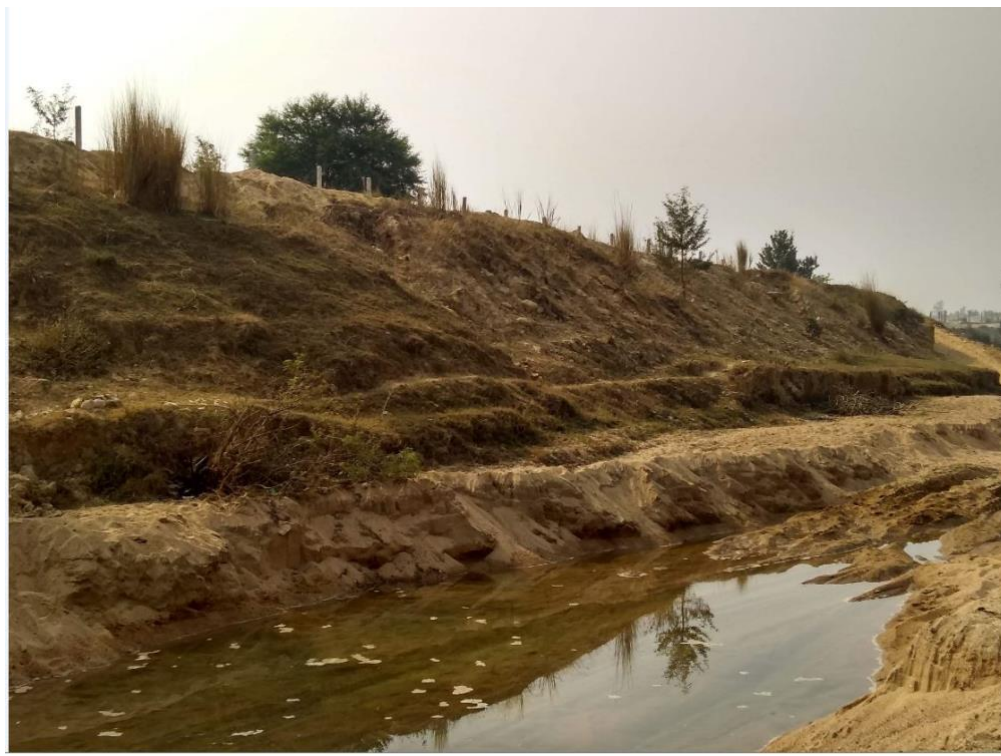
Figure 3: View of the embankment from the river bed

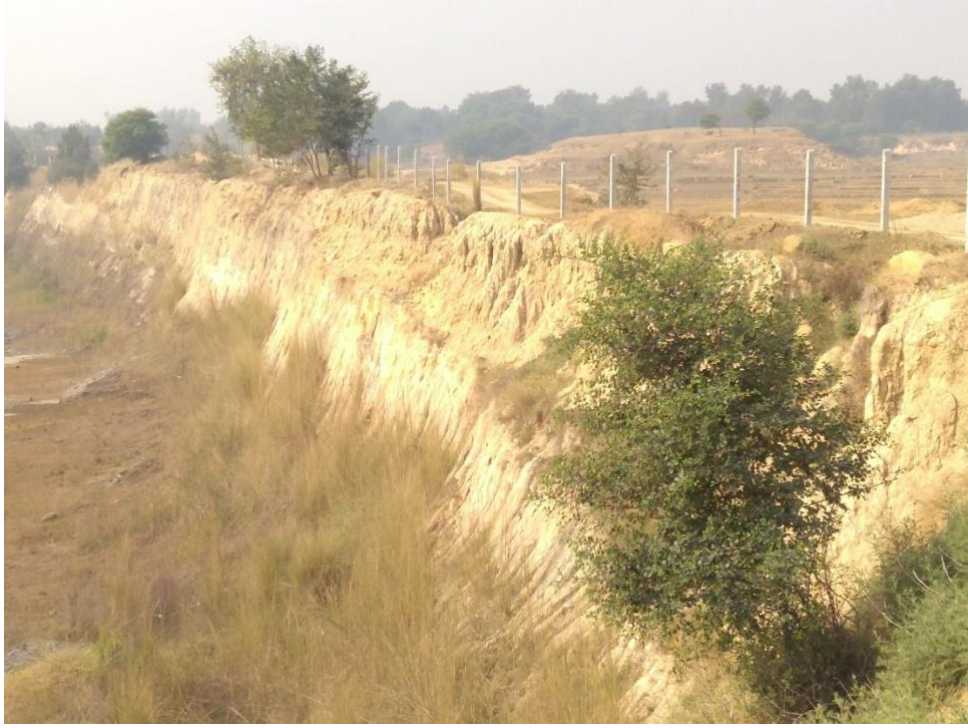
Figure 4: Embankment was on the mine site as seen from the northern end. Erosion of the wall is clearly visible.

- C. To consolidate the embankment further, it is recommended that the walls of the embankment should be pitched with boulders especially at places where gully erosion or other such irregularities are visible

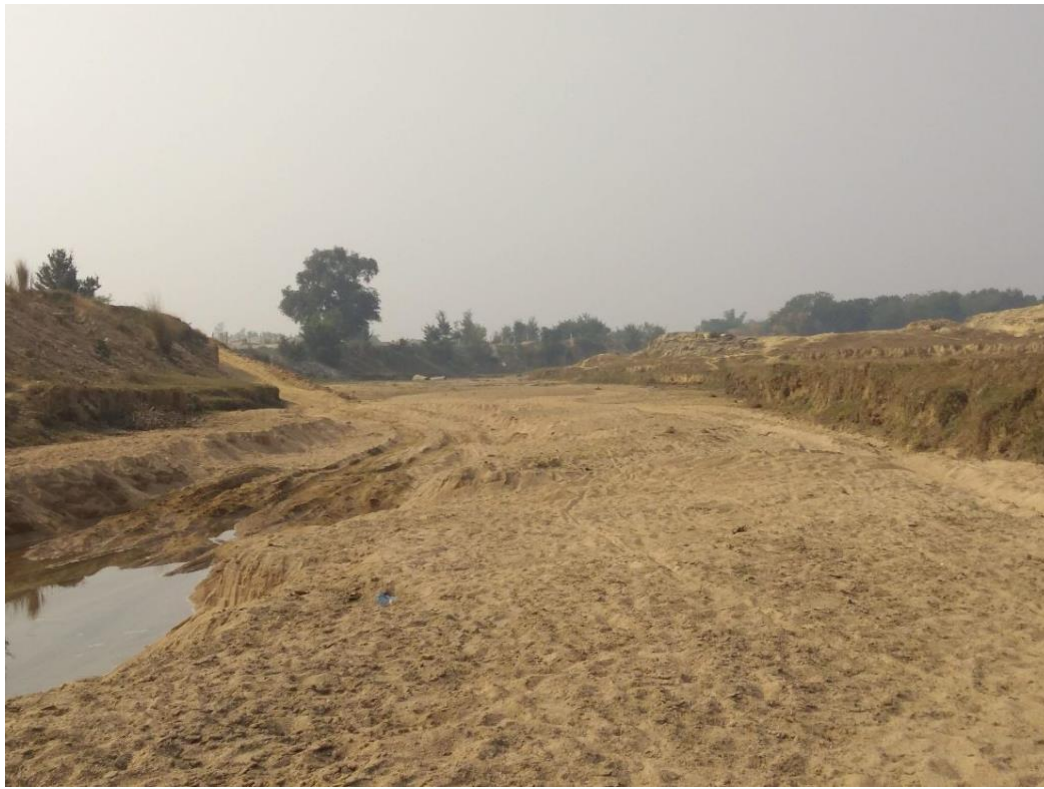
Figure 5: The complete river bed

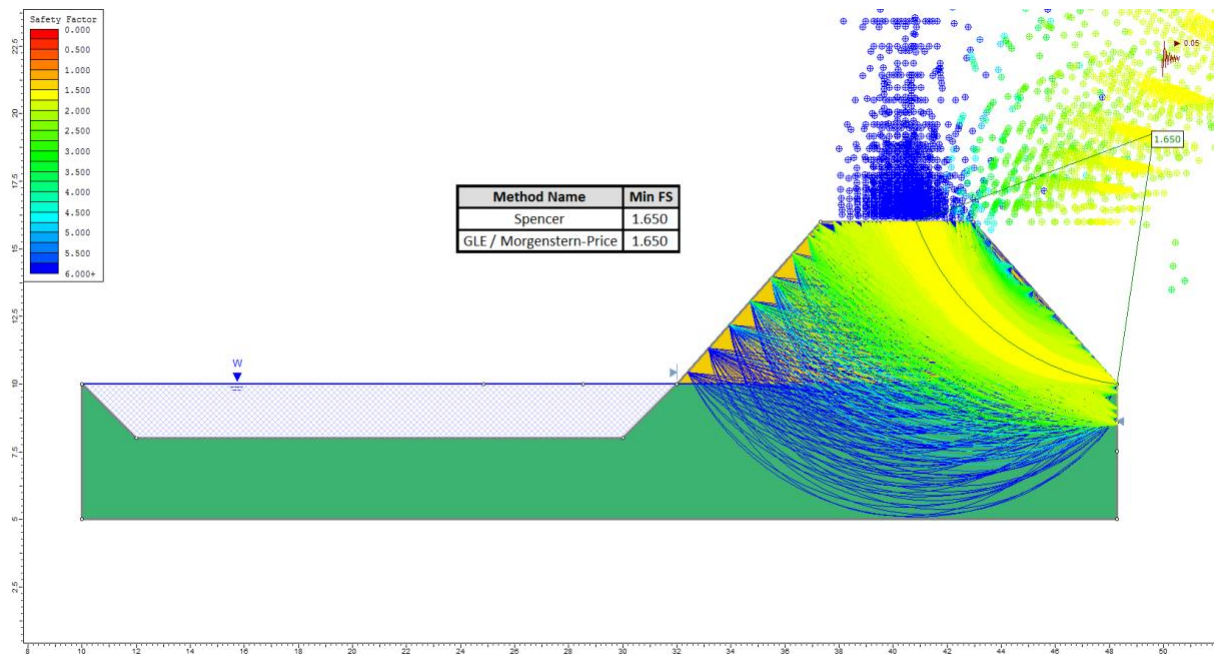
Figure 10: Results of LEA for section A-A1 under situation A

Results of Limit equilibrium Analysis for both the sections, A-A1 and B-B1, under the two situations, A and B, stated above are presented in Figure 10 to Figure 13. As can be seen from the figures, for situation A, which is the most probable situation under flooding condition, the Factor of Safety (FoS) obtained for section A-A1 using both the analysis methods, Spencer and Morgenstern Price (GLE) are identical at 1.650. For section B-B1, the corresponding values for the two methods are 1.446 and 1.469, respectively. Any FoS value in pseudo-static analysis above 1.2 can be considered to be adequate. Therefore, the FoS values for both the sections in the most probable flooding situation are very high and no stability threat is envisaged.

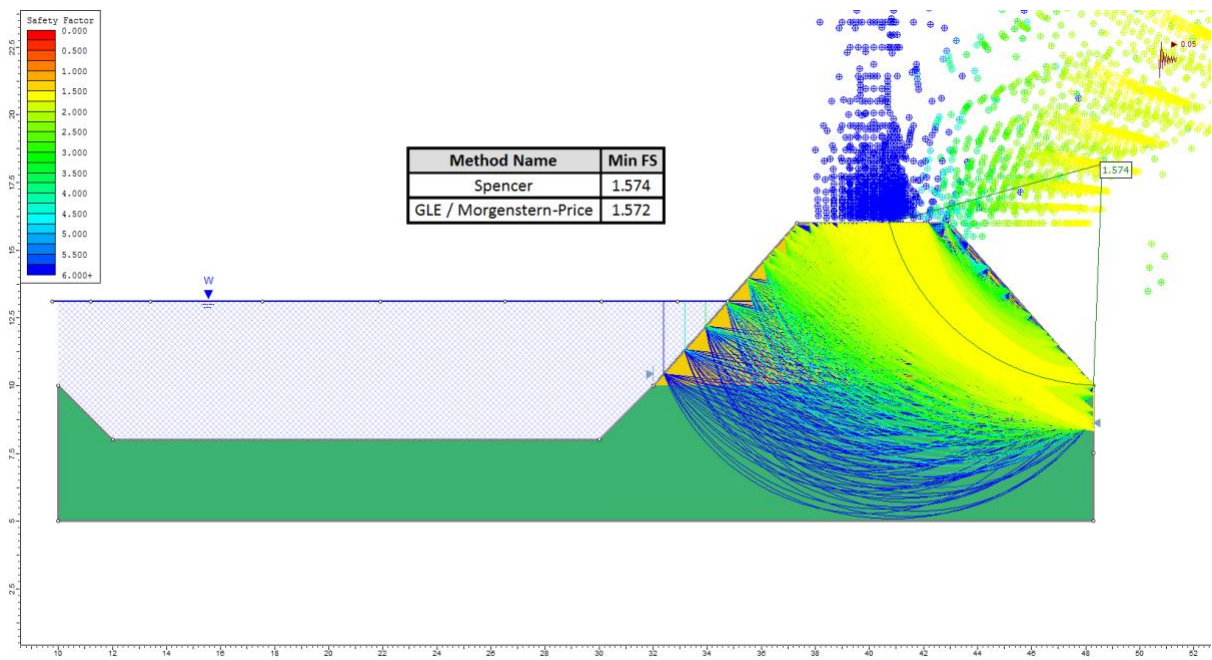
Figure 12: Results of LEA for section A-A1 under situation B

Evaluation of results for the severely extreme episode, when the water level rises 3 meter above the HFL, the FoS falls to ~1.57 for the section A-A1 and ~1.36 for the section B-B1. Therefore, in this extreme situation also, the embankment is expected to remain quite stable.
