STABILITY ANALYSIS OF RIVER EMBANKMENT AT KATHAUTIA OPENCAST MINE

Prepared for

HINDALCO INDUSTRIES LIMITED

November 2020

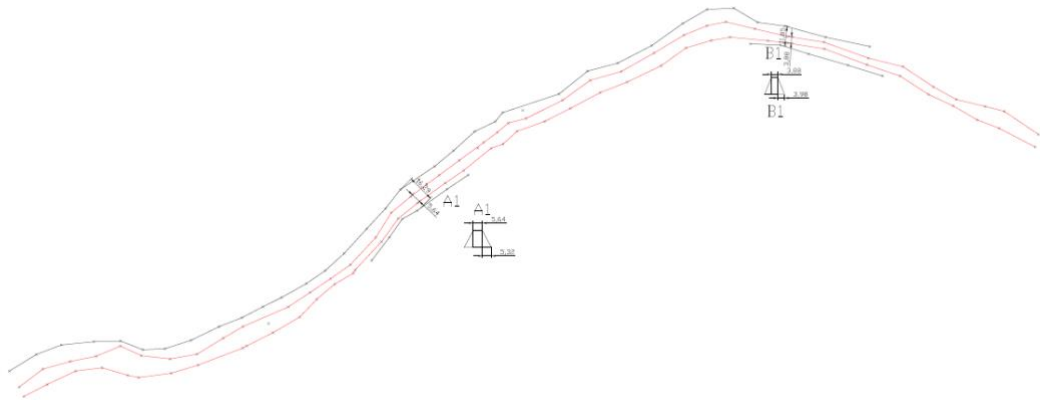
Figure 6: The complete plan of the embankment

The mine management provided the complete plan of the embankment, which is shown in Figure 6.

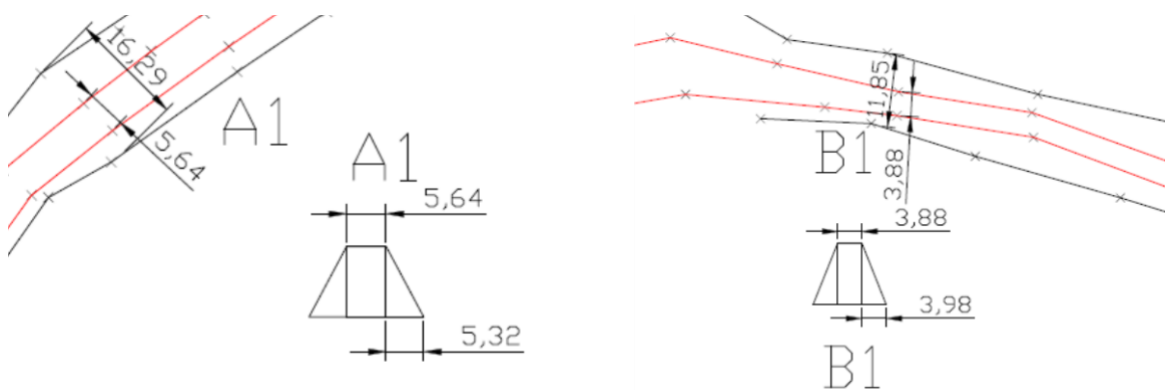
Figure 7: Survey sections of the embankment A-A1 and B-B1 on the southern and northern sides of the embankment, respectively

Along with the plan, two survey sections, A-A1 and B-B1, on the southern and northern side, respectively, were also provided. These sections, presented in Figure 7, formed the basis of further Limit Equilibrium Analysis (LEA) of the embankment.

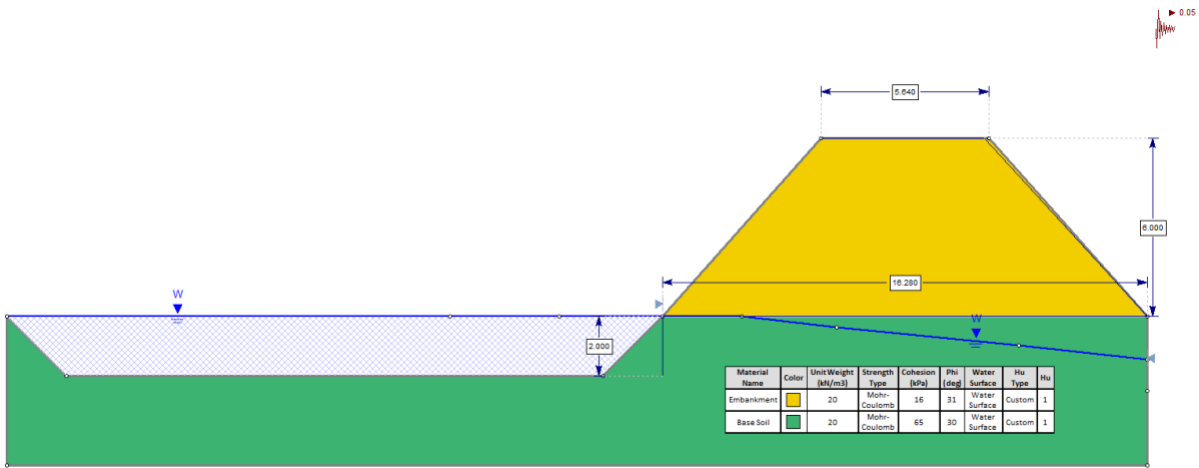
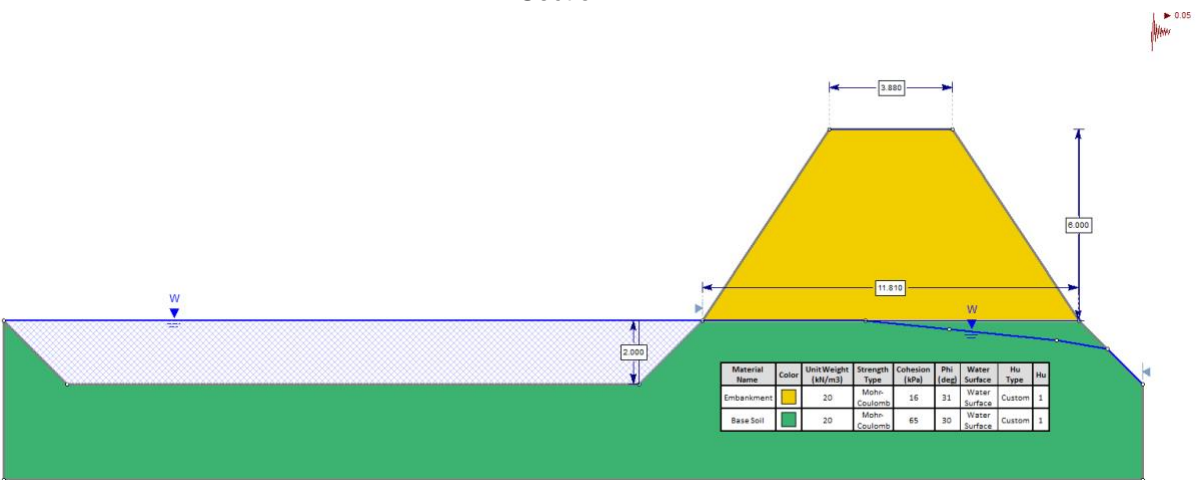
Figure 8: Basic model with dimensions for situation A (water level up to HFL)

- A. *The most likely situation*- water level in the river rises up to HFL and the embankment stays 6 meter above the water level (Figure 8).
- B. *An extremely severe episodic situation*- water level rises up 3 meter above the HFL (Figure 9). Although this is an extremely unlikely situation, for proper risk analysis, this hypothetical situation was also considered.
