Sub: Compliance Report of EC conditions for Kujam-II Bauxite Mining project of M/s Hindalco Industries Limited located in Dist- Gumla, Jharkhand for the period October'21 to March'22.

: Kujam II Bauxite Mine (157.38 ha) M/s Hindalco Industries Ltd

: J-11015/297/2011-IA.II (M) dated 21.07.2015

: From 1st October 2021 to 31st March 2022

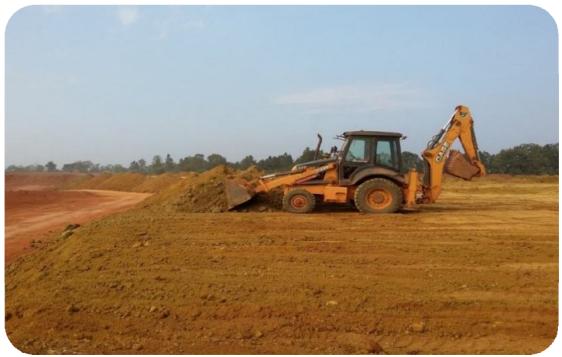
Pic: Reclamation of the mined-out area after mining.

| | Clearance is not available. | |
|---|--|---|
| xi | Concurrent reclamation of mined out areas. | Concurrent back filling/ reclamation are being carried out in mined out areas. |

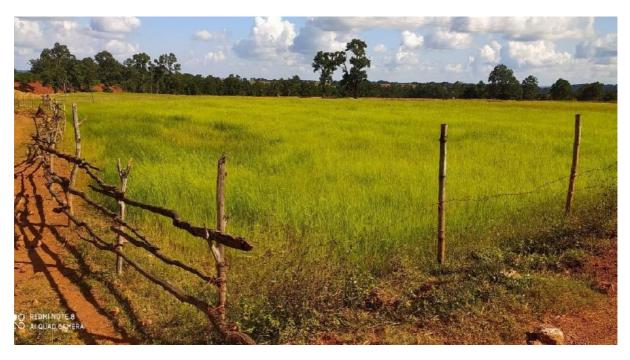
Pic: Paddy cultivation over reclaimed area.

| | | lease. In addition to this agricultural activities (bio plantation) is going on reclaimed land as per the consent from land owners. Green belt development programme is in progress with progress of mining activities. |

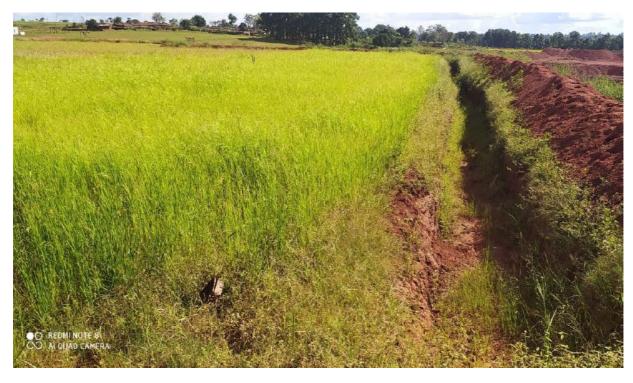
Pic: Paddy cultivation over reclaimed area.

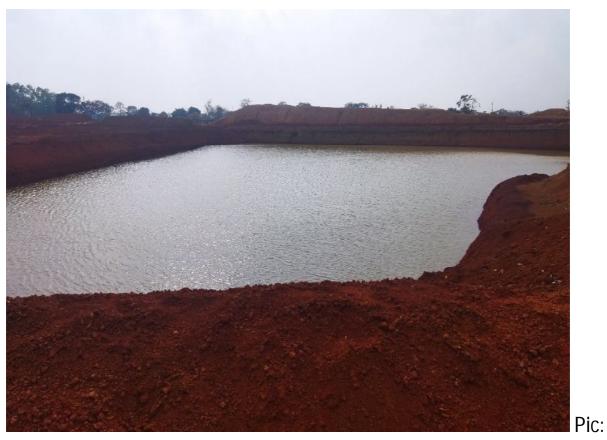
Rain harvesting pond developed after mining for the purpose of fisheries, water sprinkling & villagers use.

| | | lease. In addition to this agricultural activities (bio plantation) is going on reclaimed land as per the consent from land owners. Green belt development programme is in progress with progress of mining activities. |
|---|---|--|
| xxvi | There shall be planning, developing and implementing facility of rainwater harvesting measures on long term basis in consultation with Regional Director, Central Groundwater Board and implementation of conservation measures to augment ground water resources in the area in consultation with Central Ground Water Board. | A detail rain water harvesting plan to augment ground water has been prepared and suitable measures like water harvesting pond etc. are created for augmentation of ground water in Mine. |

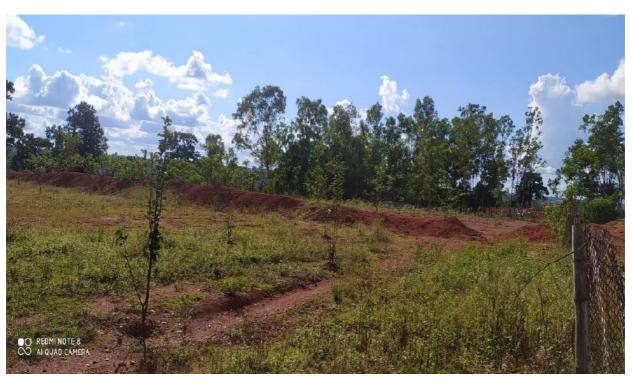
Pic: Pears plantation over the reclaimed area.

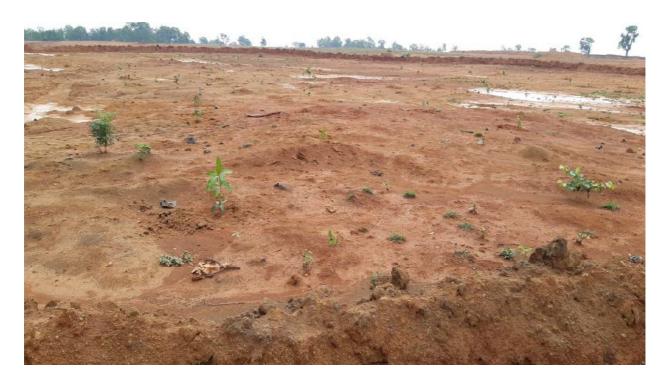
Pic: Plantation over the reclaimed area.

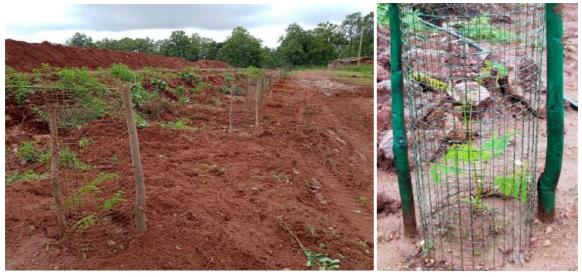
Pic: Road side plantation.

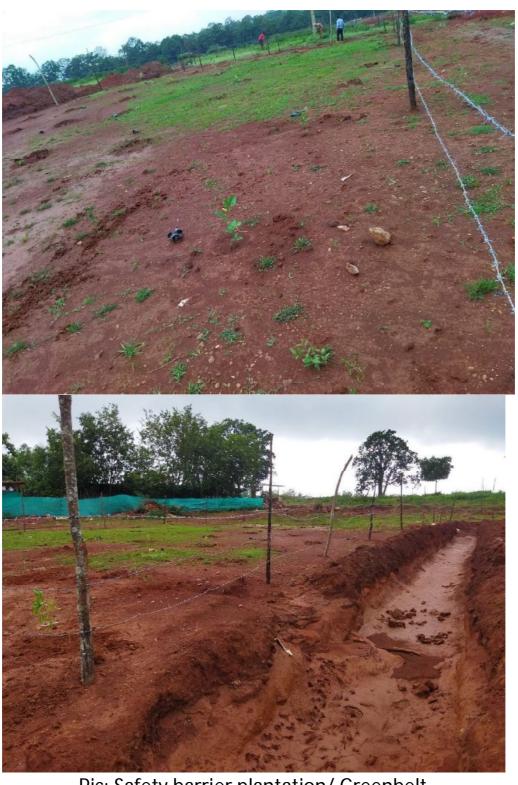
Pic: Safety barrier plantation/ Greenbelt .

| XV | Washing of all transport vehicles should be done inside the mining lease. | Being complied. | |
|---|---|---|--|
| xxii | Stratified layer system of plantation to be adopted in consultation with the State Govt., which would effectively mitigate the additional dust, sound and vibration. | Progressive plantation is being carried out in consultation with local forest Dept. Total 4150 nos. of saplings have been planted during FY 2021-22 within this | |

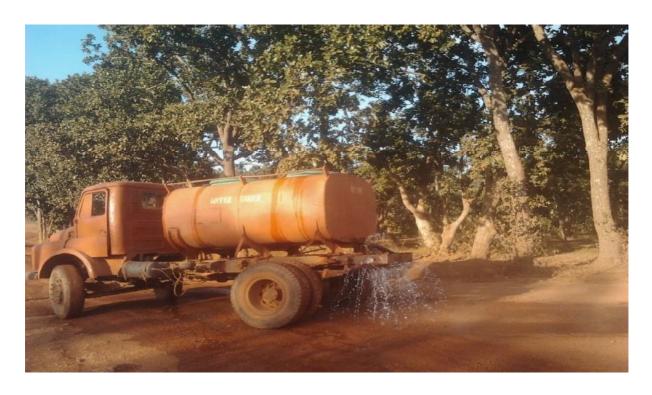
Pic: Water sprinkling on mines haul road.

| | Clearance is not available. | |
|---|--|---|
| xii | Use of effective sprinkler system to suppress fugitive dust on haul road and other transport road and comprehensive study for slope stabilization of mine benches and OB dumps in one year. | Effective water sprinkling is being done to suppress fugitive dust on haul road by mobile water tanker during dry season. No external dump as on date. |

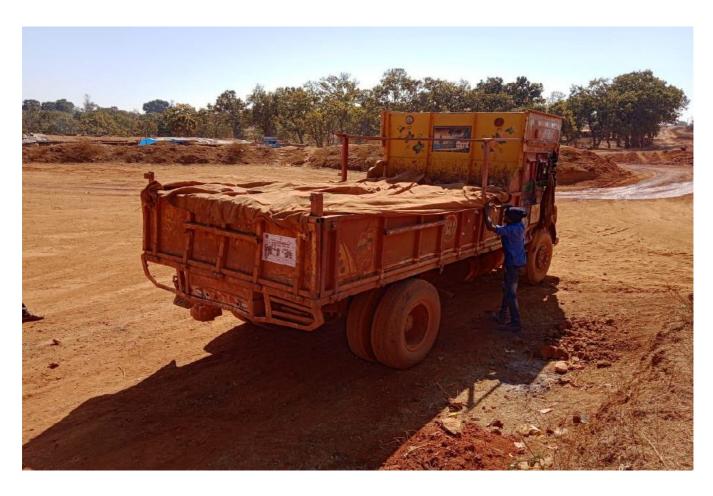
Pic: Trucks ready for dispatch with proper tarpaulin cover

| | | lease. In addition to this agricultural activities (bio plantation) is going on reclaimed land as per the consent from land owners. Green belt development programme is in progress with progress of mining activities. |
|---|---|--|
| XXV | The pollution due to transportation load on the environment will be effectively controlled & water sprinkling will also be done regularly. Vehicles with PUCC only will be allowed to ply. The mineral transportation shall be carried out through covered trucks only and the vehicles carrying the mineral shall not be overloaded. Project should obtain 'PUC' certificate from all the vehicles from authorized pollution testing Centre. | Mobile water tanker with sprinkling facility has been provided a long haul roads, loading, unloading & at transfer points to arrest dust emission. Regular maintenance of vehicles are undertaken to minimize vehicular emission. All measures are being taken to control vehicular emission. The vehicles are being covered with tarpaulin while transportation of mineral. |

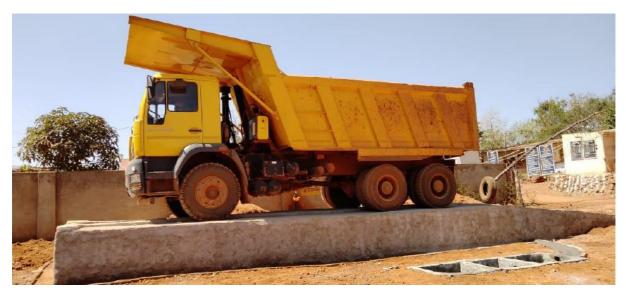
Pic: Washing platform and oil & grease trap.

| | carried out four times in a year - pre- monsoon (April-May), monsoon (August), post-monsoon (November) and winter (January) and the data thus collected may be sent regularly to Ministry of Environment, Forest and Climate Change and its Regional Office, Ranchi, Central Ground Water Authority and Regional Director, Central Ground Water Board. | mining operation at present and in future. Piezometer has been installed for monitoring of ground water level. Water quality and level report are attached herewith as Annexure 1. |
|---|--|--|
| ix | Industrial wastewater (workshop and wastewater from the mine) should be properly collected, treated so as to conform to the standards prescribed under GSR 422 (E) dated 19m May, 1993 and 31' December, 1993 or as amended from time to time. Oil and grease trap should be installed before discharge of workshop effluents. | There is no industrial wastewater generation within mine lease area. We are not discharging any wastewater outside mine lease area. However, for washing of HEMM, Effluent treatment mechanism (Oil and grease trap) has been installed in Kujam mine. |
